RECON MEDICAL GEN 4 TRAUMA TOURNIQUET TENSILE STRENGTH QUALITY CONTROL TESTING

Asher Holland
 Recon Medical, LLC
 Redding, CA, USA

In this documentation the methodology and results for tensile strength quality control testing Recon Medical GEN 4 trauma tourniquets will be discussed. 53 GEN 4 trauma tourniquets were tested, and the average ultimate tensile strength was 2319.0 pound-force. The most frequently occurring failure mode was the internal webbing, followed by Velcro delamination, heat weld, and lastly the buckle.

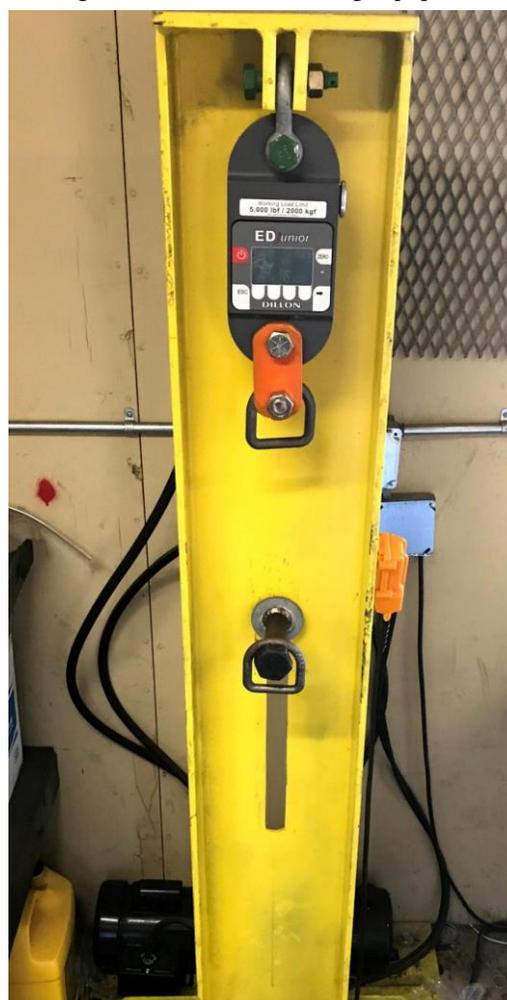
Figure 1: Destructive Testing Equipment

1 out of every 500 tourniquets, or 0.2%, of all inventory received from manufacturing facility is tensile strength tested using destructive testing equipment (see figure 1) to determine ultimate tensile strength. It is vitally important when tensile strength testing that the windlass is turned 450 degrees from its initial resting position and then secured in the windlass retainer plate (see figure 2). This activates the internal “floating” webbing which is designed for carrying the tensile load. The piston then moves the lower attachment point downward applying a tensile load to the tourniquet. The ultimate tensile strength is recorded at moment in which the tourniquet fails to

maintain resistance to tensile force. The pound-force at moment of failure is recorded by a Dillon EDjunior dynamometer. The tourniquet can then be removed from equipment, failure mode documented, and the testing is now complete.

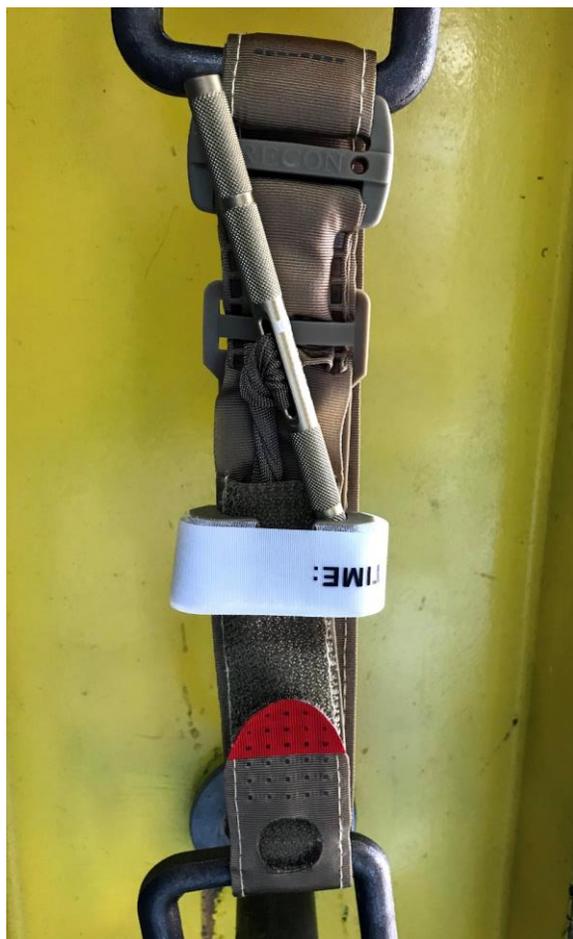
Figure 2: Windlass rotated and secured in windlass retainer clip with time strap fastened ready for testing

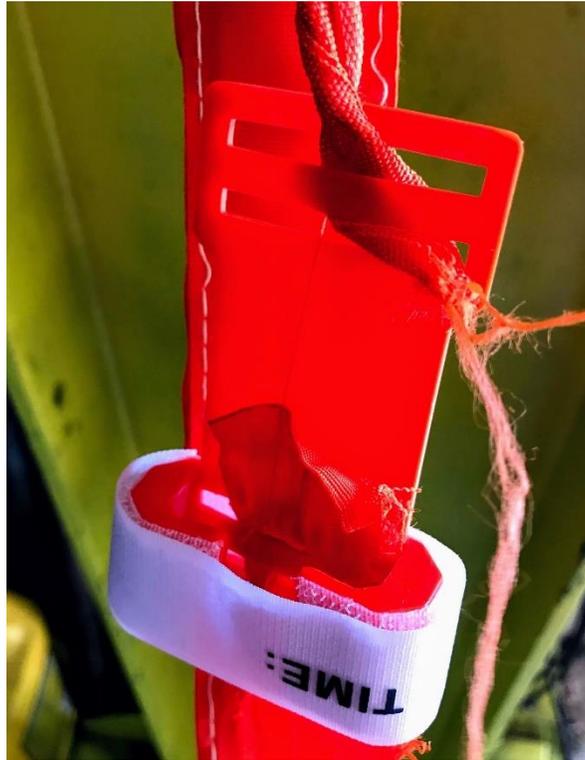
Figure 3: Internal Webbing failure

The tourniquet is designed so that the internal 1-inch wide nylon webbing will carry the tensile load. A failure at this point is intentional and is no concern unless the failure occurs below the minimum 2000 pound-force threshold.

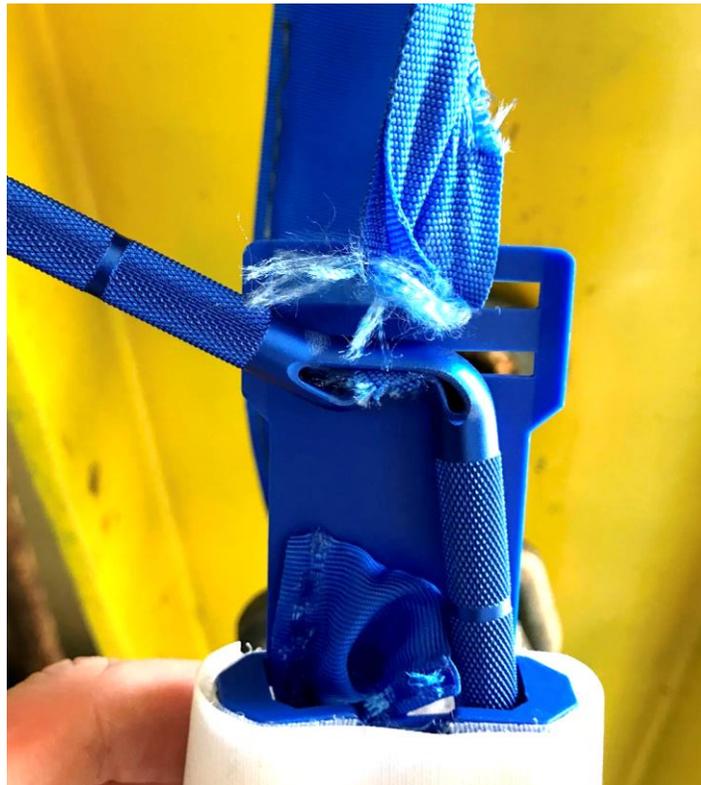
Figure 4: Internal webbing failure

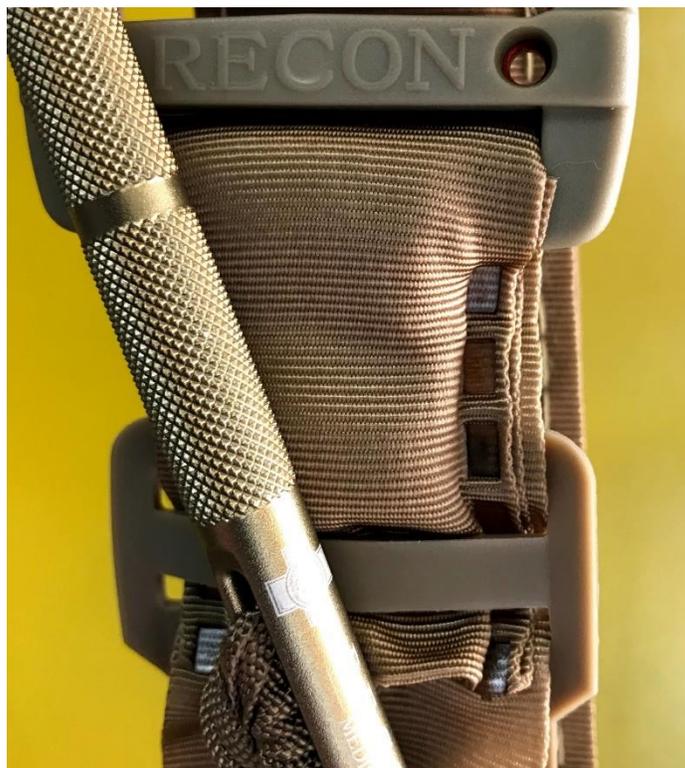
Figure 5: Detailed view of heat weld

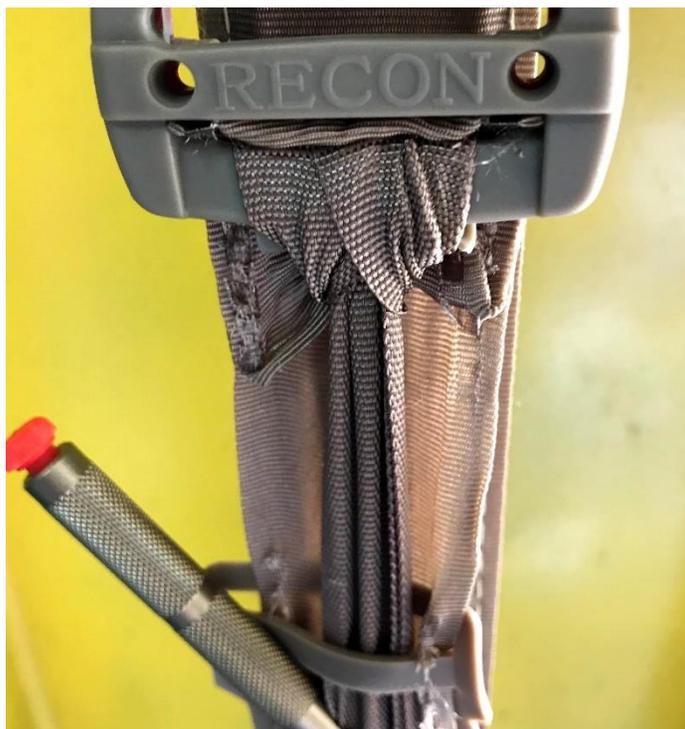
Figure 6: Heat Weld Failure

The heat weld failure mode is the 3rd most reoccurring failure mode and is currently under review for root-cause and potential corrective action. This failure does not occur below the minimum 2000 pound-force therefore it is not a critical issue.

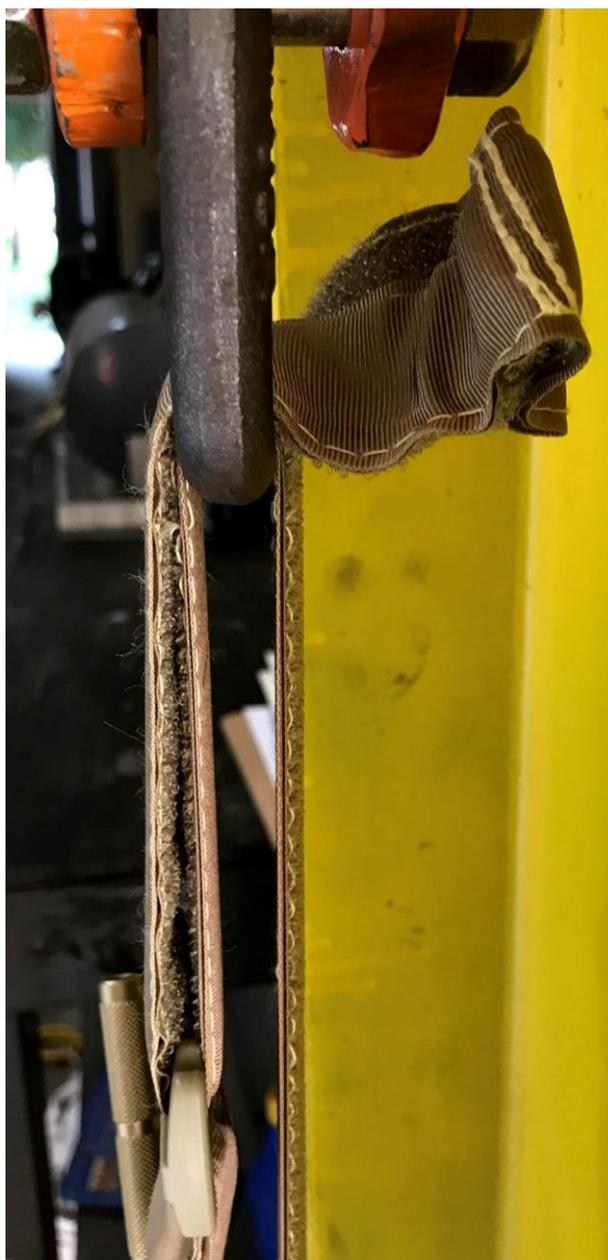
Figure 7: Velcro Failure

The 2nd most reoccurring failure mode is Velcro delamination. This failure mode also does not occur below the minimum 2000 pound-force therefore it is not a critical issue. This issue is also under review for root-cause and potential corrective design improvements.
